## COATINGS FOR LIGHTING PROTECTION OF STRUCTURAL REINFORCED PLASTICS

TECHNICAL REPORT AFML-TR-70-303 Pt. I

March 1971

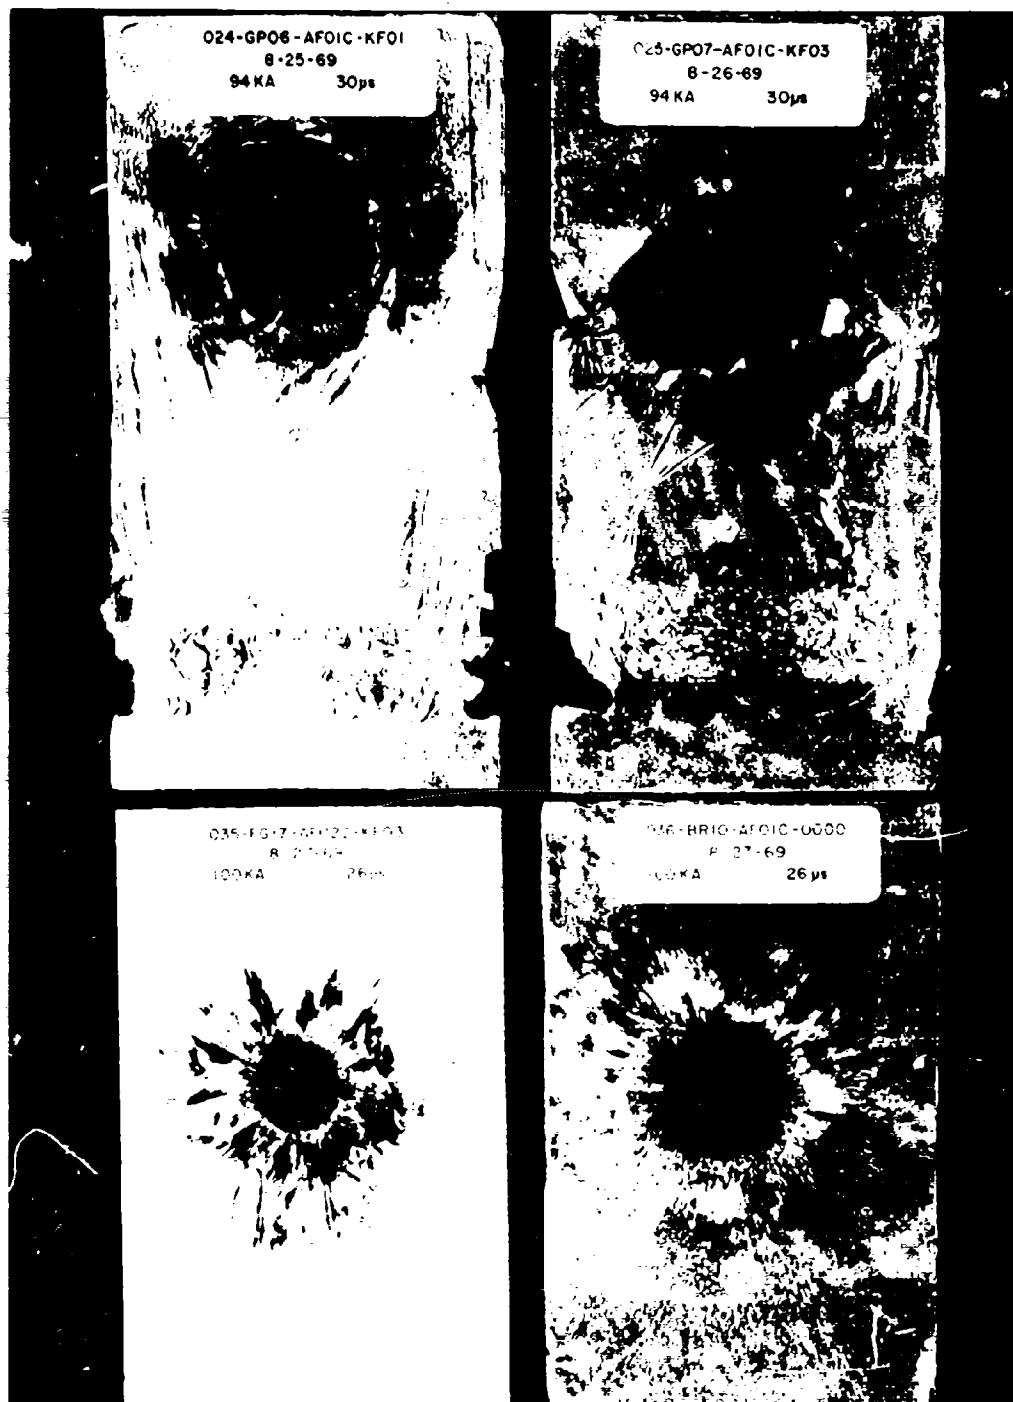
Figure 17 LIGHTNING DAMAGE TO ALL MINIMUM COATED COMPONENTS

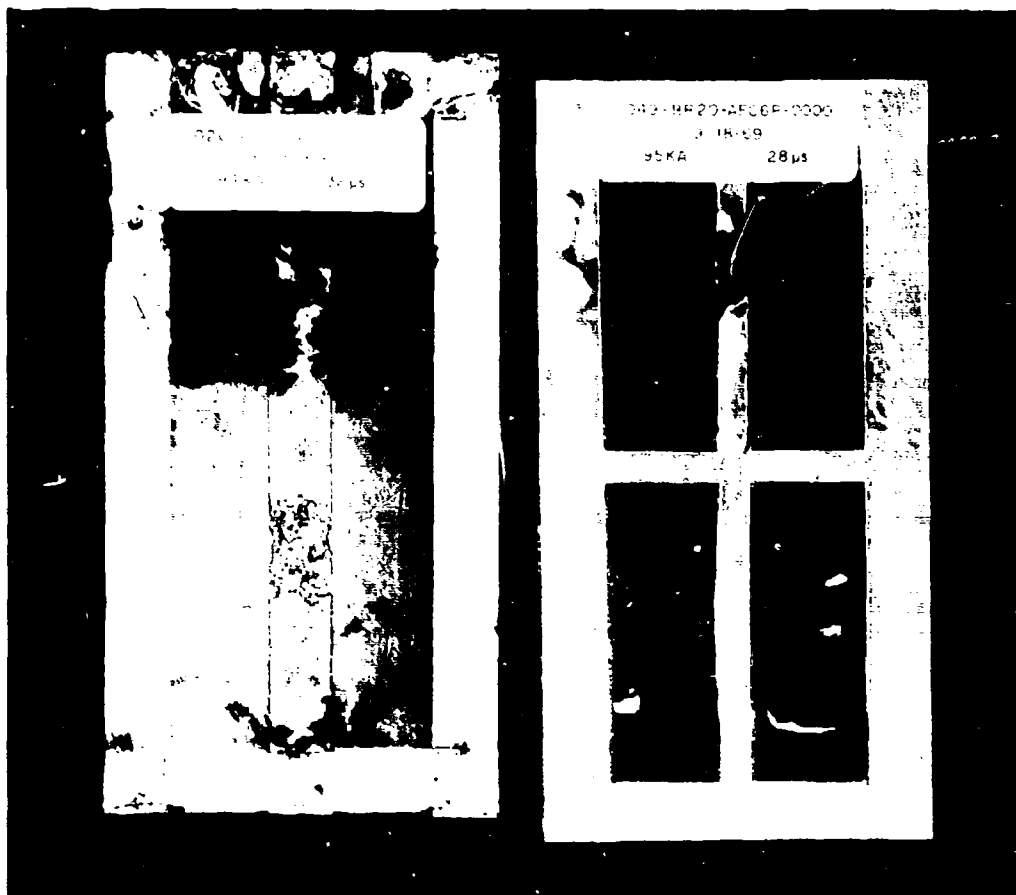
Figure 25: LIGHTNING DAMAGE TO EXPENDABLE METAL STRIP COATINGS

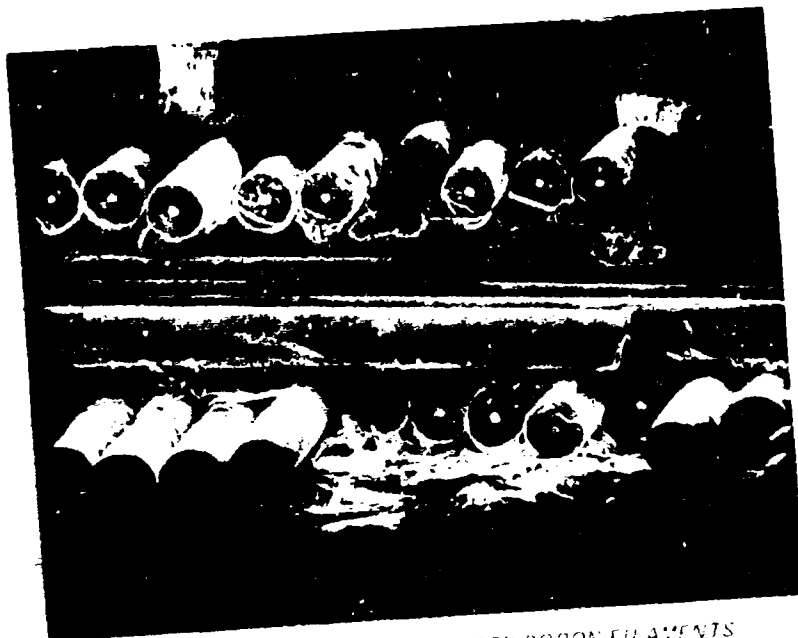
An interesting sidelight to these tests was revealed by an electron scanning microscope investigation of damage to boron filaments. A portion of the damage area is shown in Figure 87. Clearly visible is the filamentary nature and bidirectional character of the composite. The area shown is nearly free of resin as this was burned away by the electric current. The actual fracture of the filaments probably occurred as a result of rapid expansion of pyrolysis gases during the test.

Figure 87 SEM VIEW OF DAMAGED BORON FILAMENTS

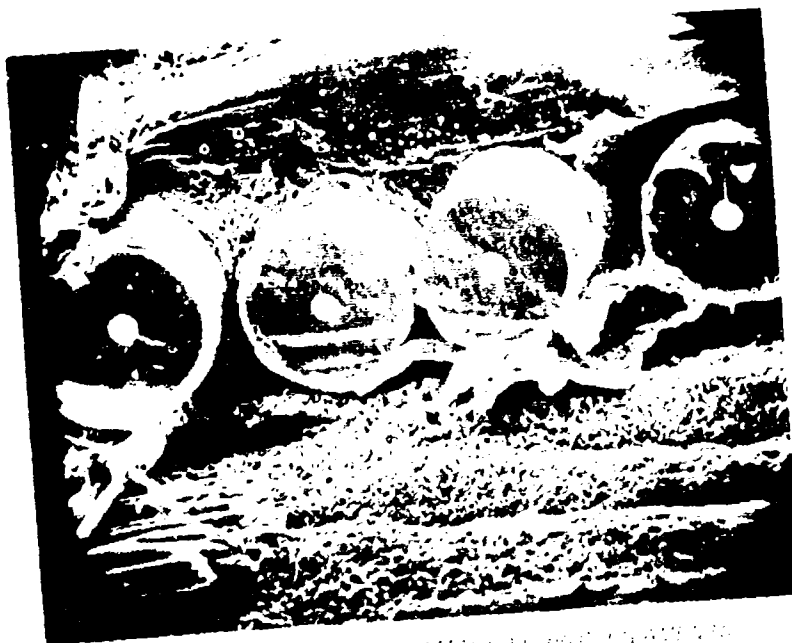
A closer view of the composite is shown in Figure 88. The lower right hand side of this picture is a view of residual resin. The upper portion is of the scrim backing material which supports the preimpregnated filaments. The boron filaments clearly illustrate the boron sheath which surrounds the tungsten containing core. Three additional features are prominent in this view. The core of all of the filaments displays evidence of melting and resolidification. This is particularly obvious when compared with other views such as that in Figure 15b. While the filaments of Figure 15b are fractured, the core material is homogeneous. The core material of Figure 88 is not homogeneous, but shows distinct grain boundaries. These are more clearly illustrated in Figure 89. In this view of the core, the black area represents the boron sheath while the lighter area is the 0.0005-inch diameter core. Clearly visible are the grain boundaries in the core section. Additionally, both the lack of a grain structure at the edge of the core and the darker shading of this section indicate this material is different in its chemical nature than that of the interior portion of the core. This region is known to be boron rich, which accounts for its different behavior (7). The thickness of the boron rich portion of the core was determined from this photograph to be nearly 0.00005 inches (1.2 microns). This is in good agreement with electron microprobe X-ray analysis which reported a boron rich region 2 to 3 microns thick (7).

Another prominent feature of Figure 88 is the interior crack displayed by the filament on the left side. This flaw is not visible from the outside of the filament. Finally, all of the filaments display a series of holes which are generally near their outer boundaries although some of the filaments have holes nearer their centers. These are more prominently displayed in Figure 90. This shows the holes to be deep and of non-uniform cross-section. Additionally, an unidentified sheath exists about the filaments. This too is very porous.

These filament flaws undoubtedly lead to poor structural performance and the loss of strength and modulus of the filaments. It appears probable that these flaws are inherent in the material and are not due to lightning currents. This is because the void areas do not display an indication of the cracking which would accompany melting or vaporization due to joule heating.

Figure 88 SEM VIEW OF DAMAGED BORON FILAMENTS

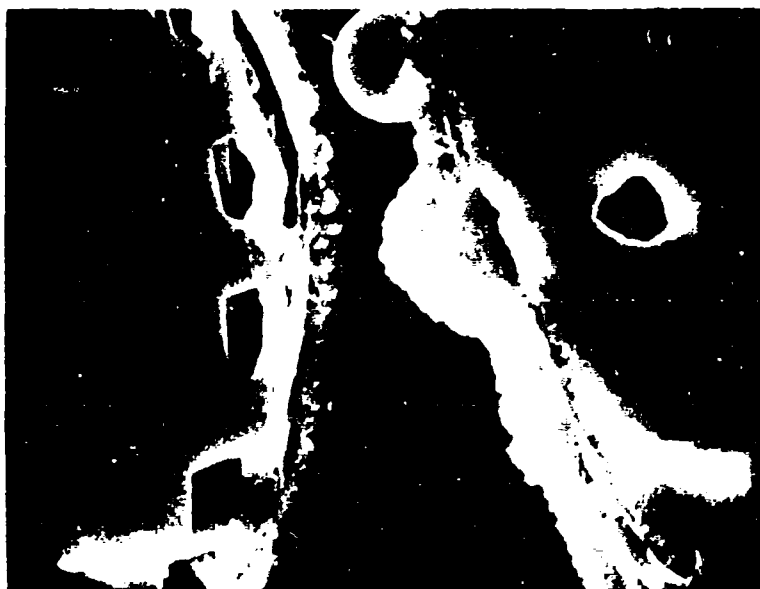
Figure 12 SEM VIEW OF DAMAGED CARBON FILAMENT

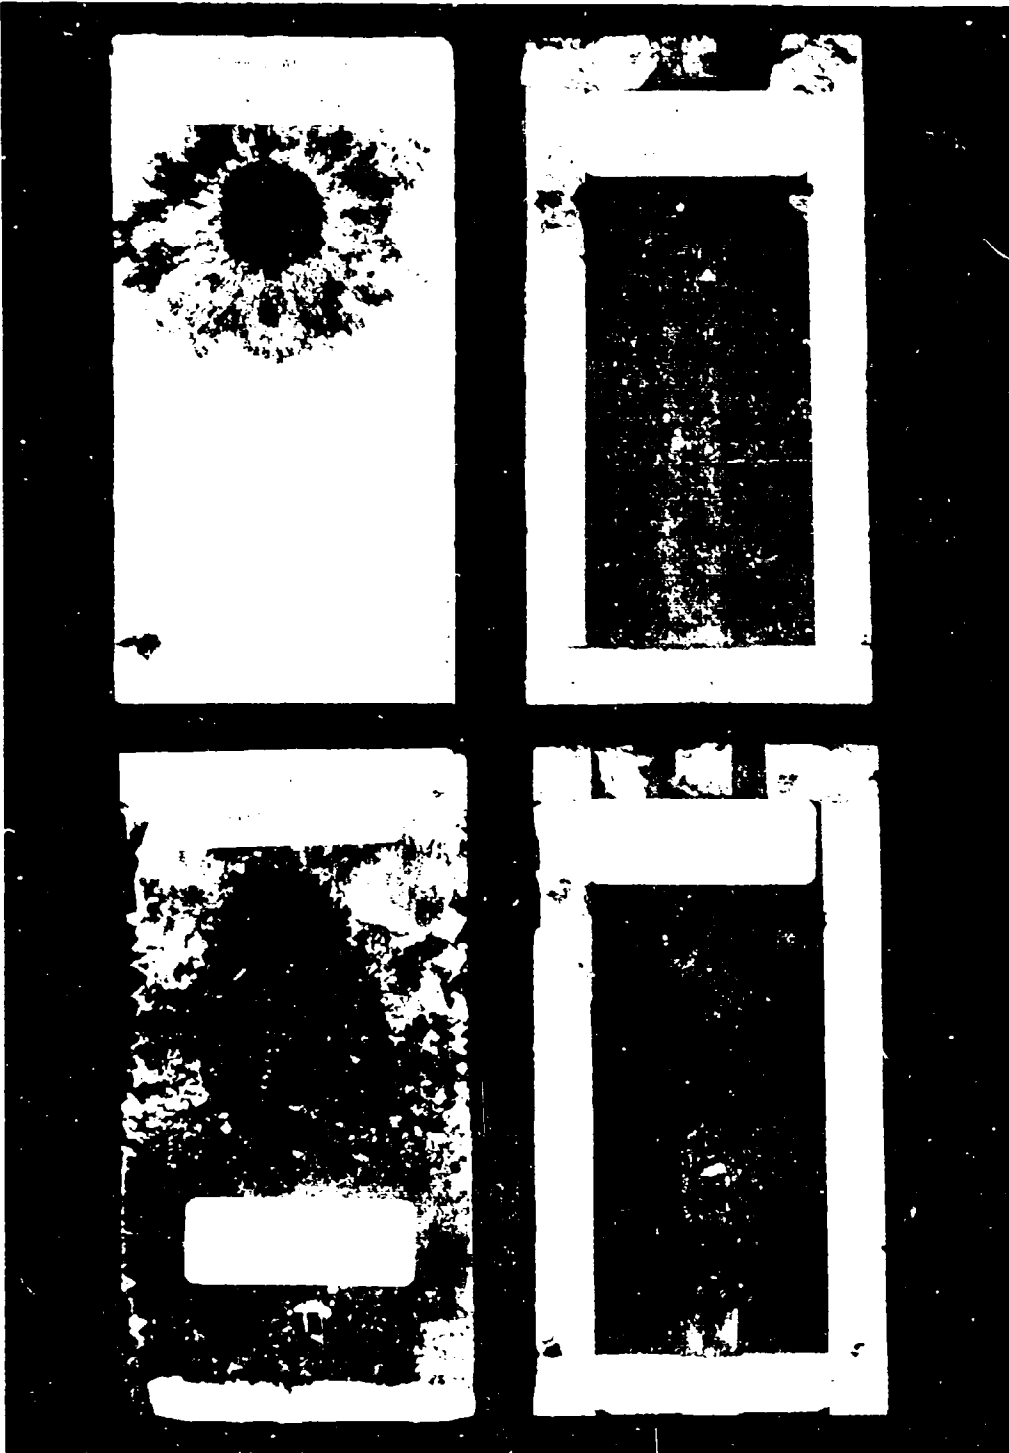
Figure A-5

No visible damage to the substrate was observed. However, the center tape was completely vaporized, the top tape (the tape on the end other than the grounded side) was severely burned and there was also very bad bubbling and pitting between the overlapped area of the tapes.

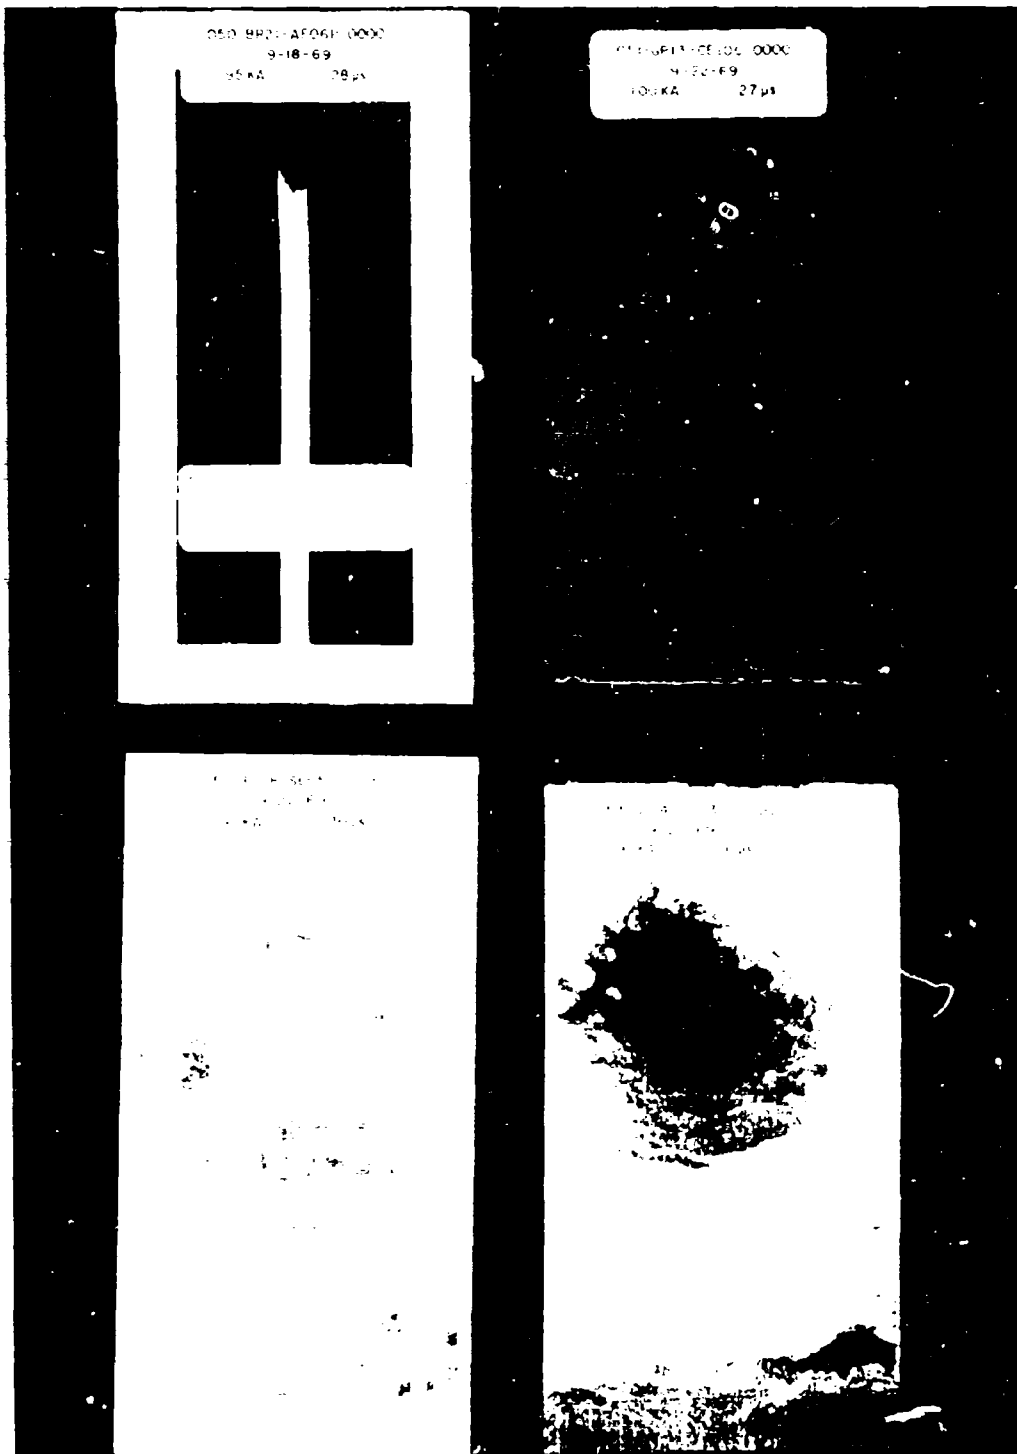
No visible damage to the fiberglass panel was observed.

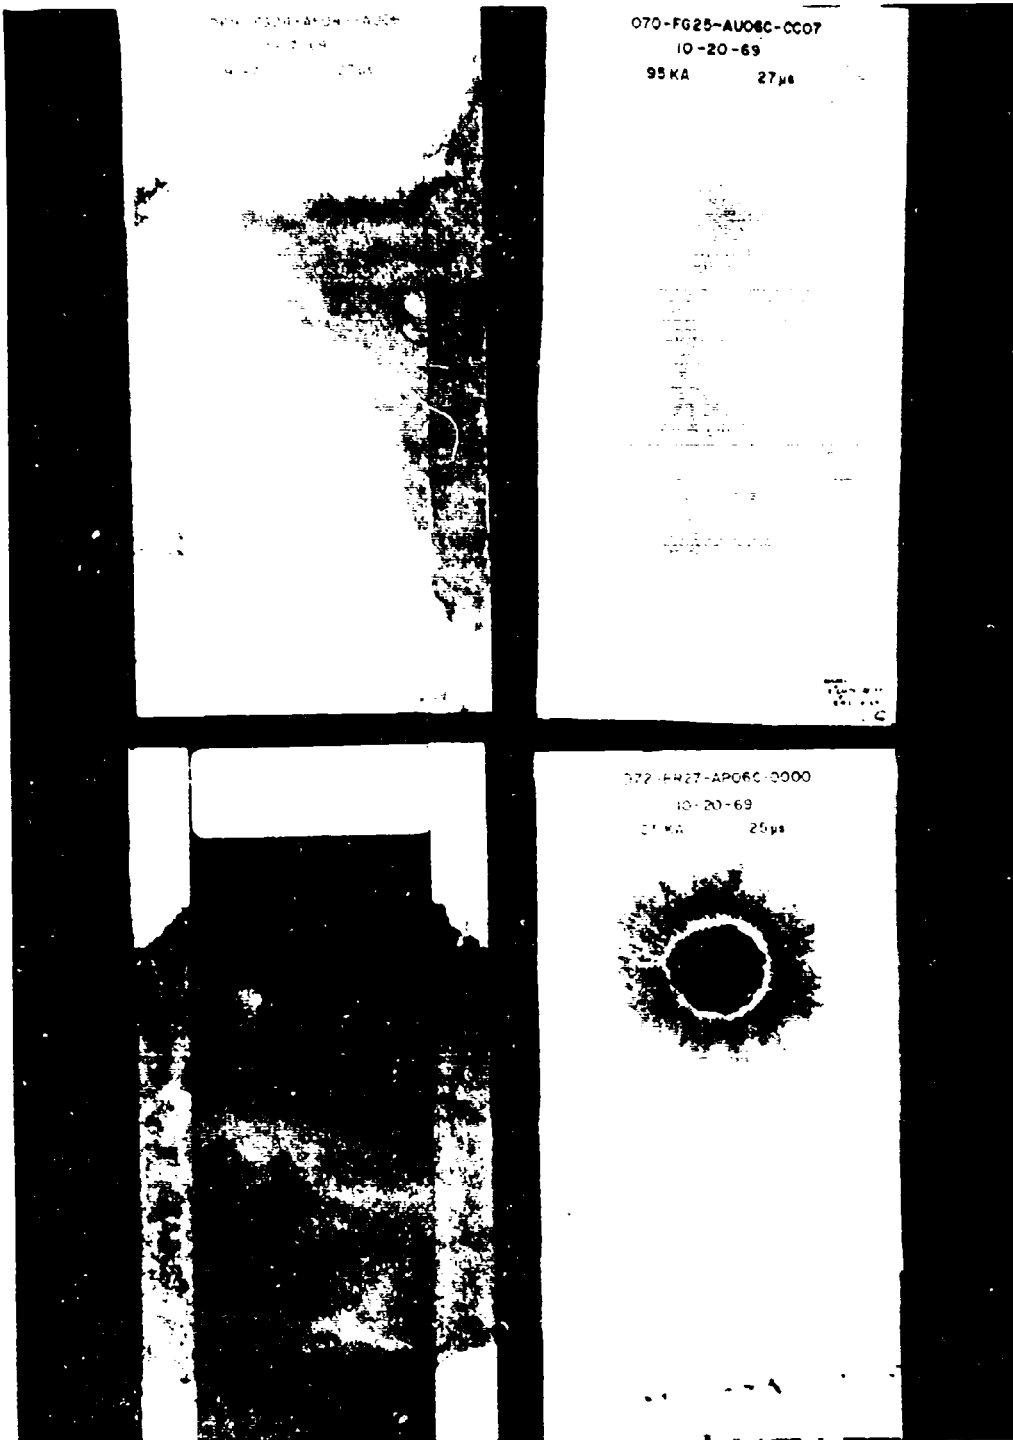
070-FG25-AU08C-CC07  
10-20-69  
95 KA 27  $\mu$ m

This boron panel was coated with a 2-mil plasma-sprayed aluminum paint with no undercoating. An 18 KV discharge was initiated to this coated panel; the discharge current had a peak of 100 KA with a risetime of 13  $\mu$ s and a duration of 25  $\mu$ s.

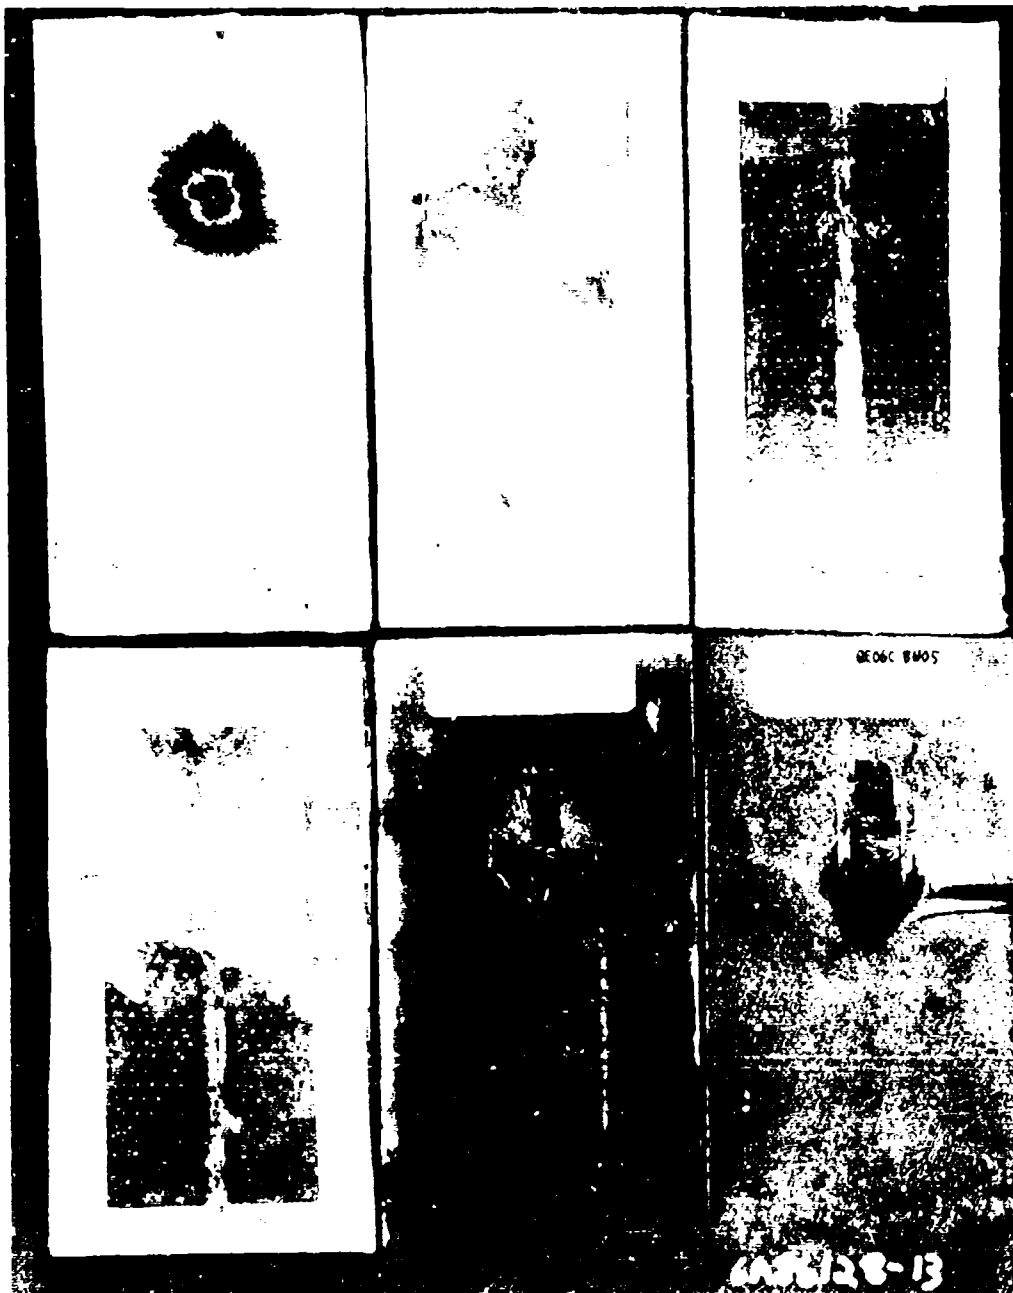
140-GP48-QE06C-BR05      Figure A-31      January 6, 1970

This graphite panel was coated with a 6-mil Araldite 488E32 thermoplastic epoxy paint which was filled with 325 mesh, 99.9 percent pure aluminum powder and MTNS carbon black, a thermal carbon with a moderate resistivity. A 5-mil undercoat of 45 percent boron nitride in the same epoxy

was employed. An 18 KV discharge was directed to this coated panel; the discharge current had a peak of 93 KA with a risetime of 15  $\mu$ s and a duration of 29  $\mu$ s.

The substrate was severely damaged.
